## Memo

**Subject** Cooks River Waterway Asset Condition Assessment – Foreshore Public Safety Assessment  
**Project** 0621090  
**Distribution** Claire Wheeler, Cooks River Alliance  
**Date** 26 August 2022

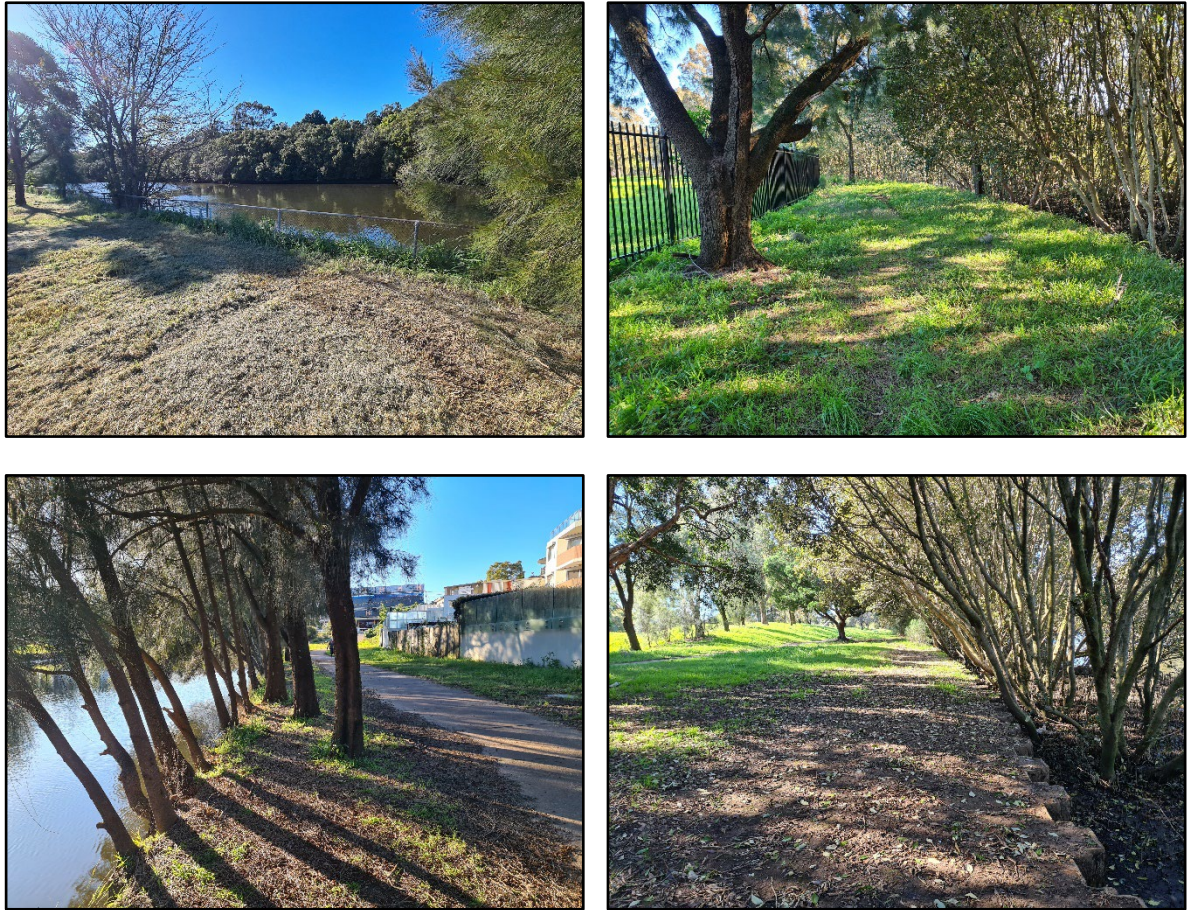
Examples of low hazard reaches are shown in Figure 3, including those where there is an existing fence or tree barrier or where there is no public pathway in the riparian corridor.

**Figure 3:** *Photographic examples of low hazard reaches*

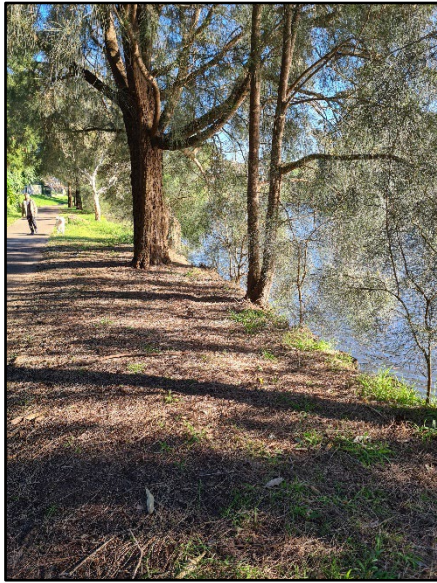
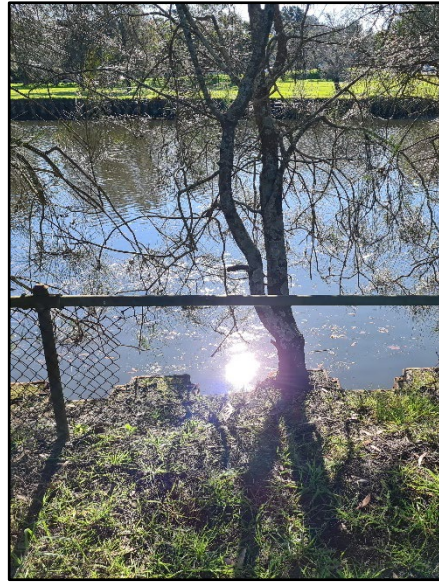
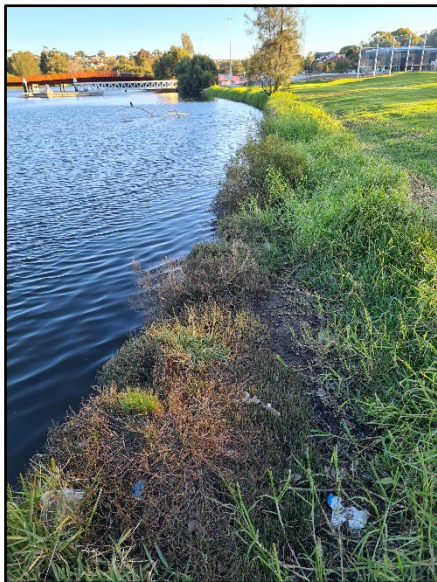
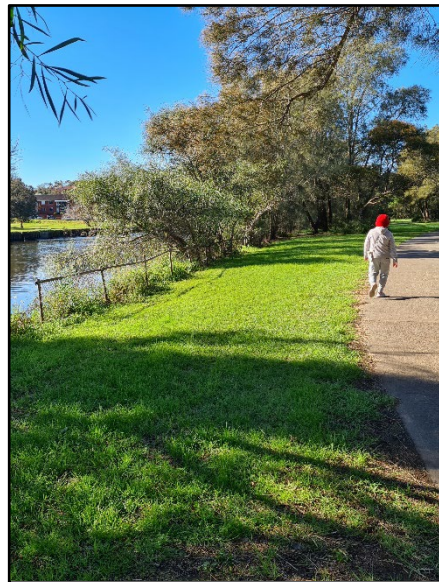
The reaches scoring as medium hazard (shown in Figure 4) generally exhibited moderate to poor condition of the sheet piling. however, it is unlikely that people will access the sheet pile edges due to a moderate vegetation cover or a constructed barrier though in poor condition.

**Figure 4:** *Photographic examples of medium hazard reaches*

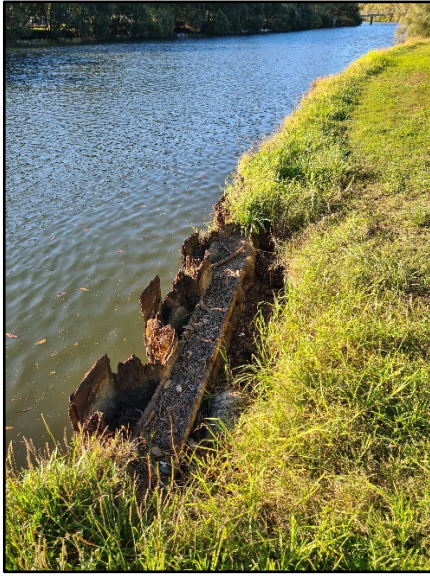
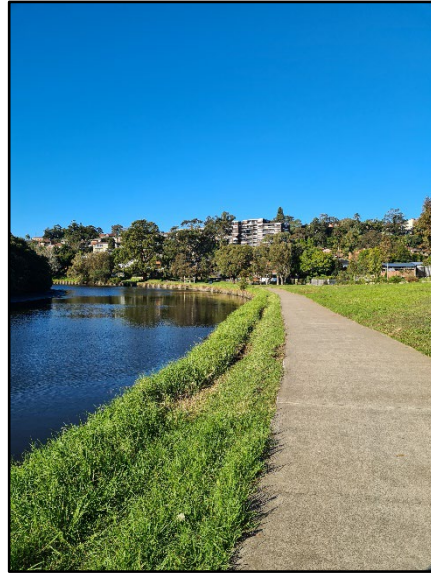
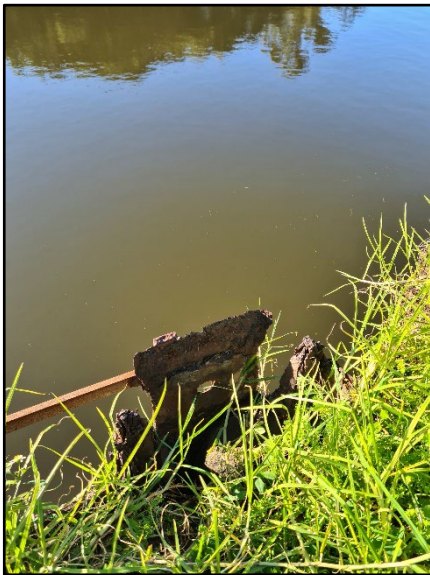
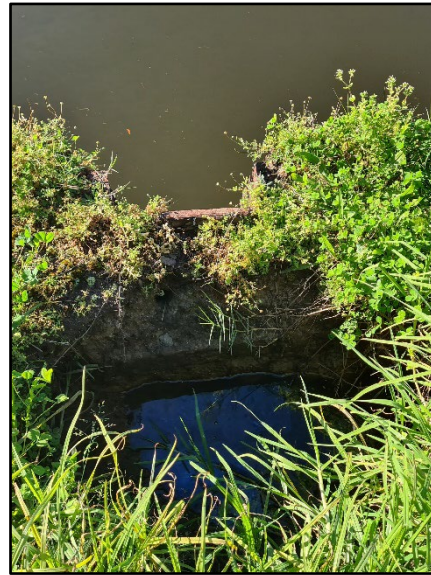
A common characteristic of the high hazard reaches (shown in Figure 5) is poor sheet pile condition, the lack of any barrier (be it natural or constructed), and regular public use of the land immediately adjacent.

**Figure 5:** *Photographic examples of high hazard reaches*

We recommend that urgent management measures are implemented at all shorelines scored as high hazard in the MCA. The reaches that scored a high hazard category were those with little or no barrier excluding people and an exposed edge of the sheet pile. The reaches receiving a score of low or medium, generally have an existing constructed barrier such as a fence, sheet pile capping, and/or natural barriers such as trees or wide-open space zones. These barriers mean that public access is not easy nor evident and as a result works are not perceived to be urgent. The high hazard shoreline reaches amount to a total of 1.43 km of shoreline in a total of 15 reaches, as shown in Figure 6.

On a balance of cost, sustainable material selection, visual appearance, resistance to flood flows and a low chance of blocking flood debris, we propose a timber post fence be installed. The estimated installation cost to install these at all high-risk shoreline is approximately \$93,000. This does not include any contingency. A concept sketch of the proposed mitigation measure is shown in Figure 8.

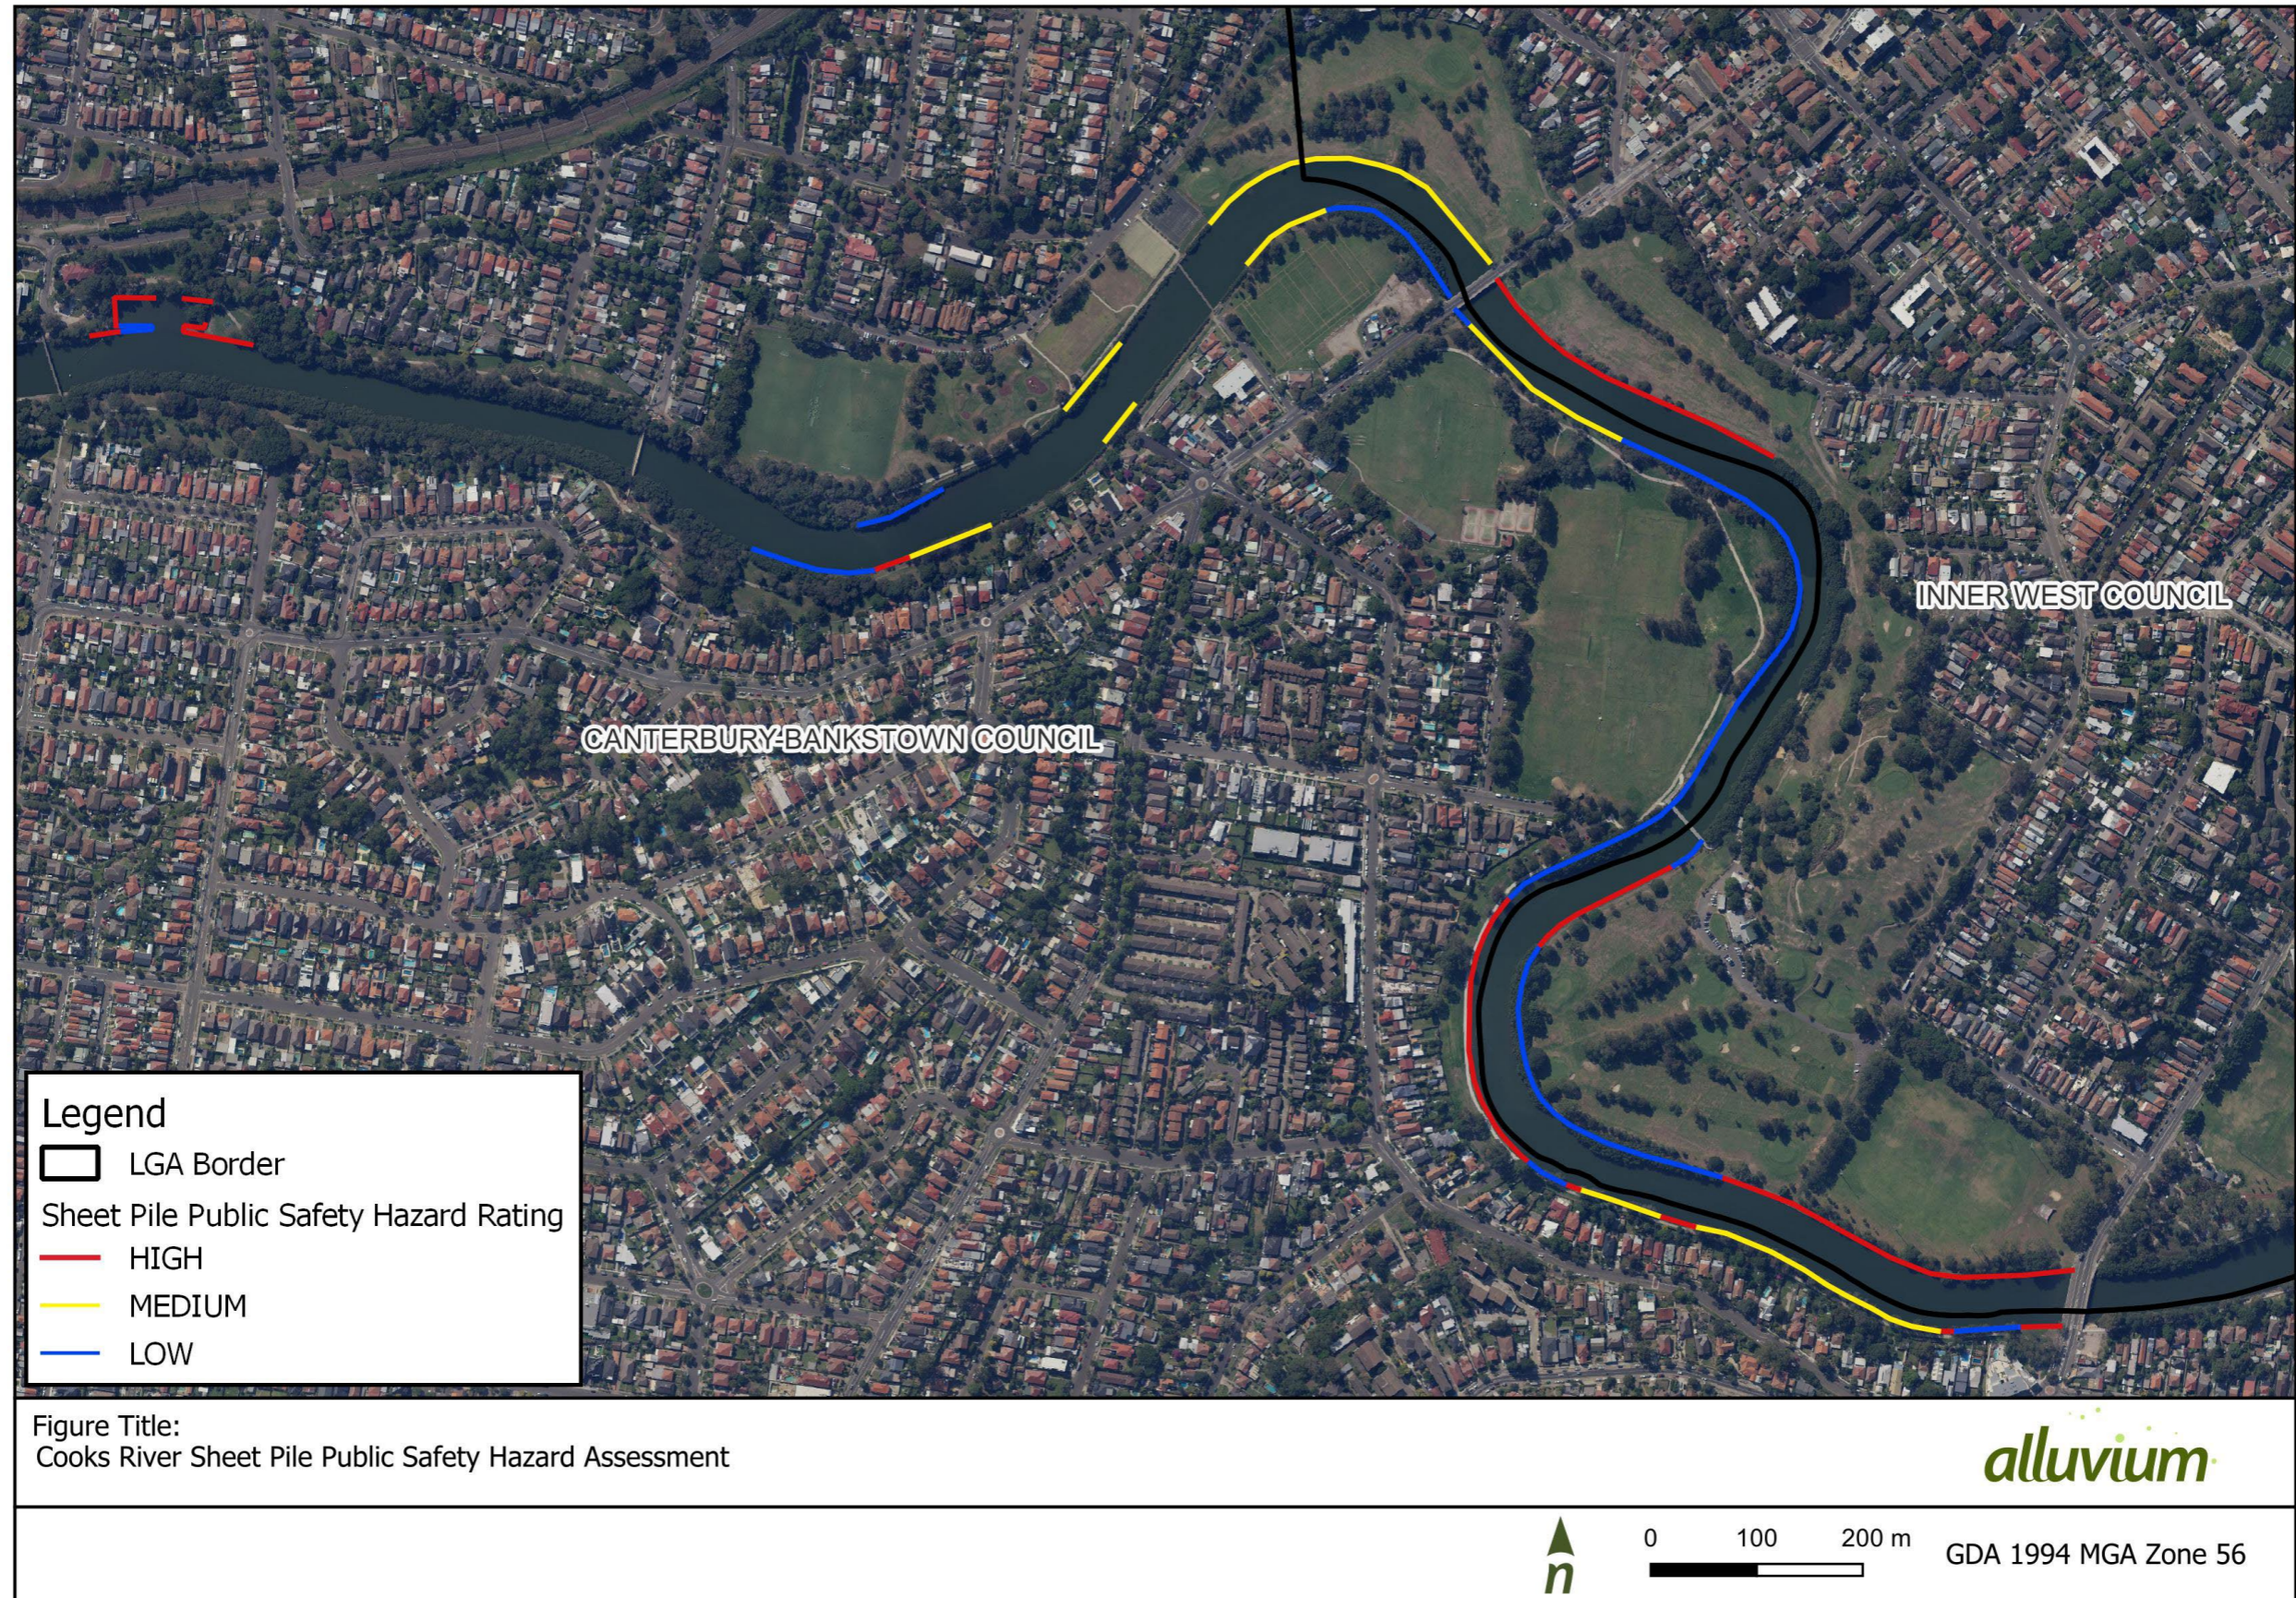
Figure 6. Results of sheet pile public safety hazard assessment

The modified MCA results were used to create a shapefile indicating the hazard rating for the different reaches of shoreline within the study, which is shown in Figure 6. These results are summarised in Table 2.

Hazard rating	Left bank length	Right bank length	Total length
High	1.02 km	0.41km	1.43 km
Medium	0.40 km	0.73 km	1.13 km
Low	0.53 km	1.05 km	1.57 km

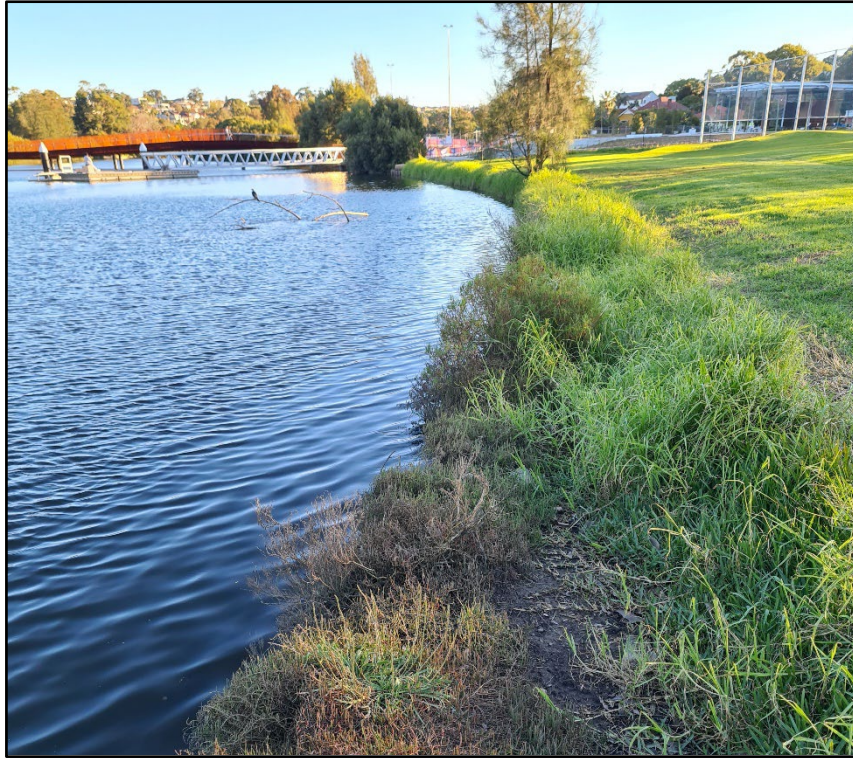
Additionally, fences can also help to create a vegetated barrier by providing an unmown strip between the fence and the sheet pile. The strip could be planted out, or simply left for the existing groundcover species to establish. An example of where this has been done was observed on the upstream most part of Marrickville Golf Course (Figure 7).

**Figure 7:** *Example of a vegetated barrier*
